Subjects: Dock and Sea Trials "RTA 1" Catamaran Passenger Ferry
Metal Shark Franklin, LA.

The following was observed during my visit of April 27, 2018

First Catamaran Ferry "RTA 1"

Two (2) 32.0 (m) X 7.7 (m) X 1.35(m)RTA Passenger Ferries

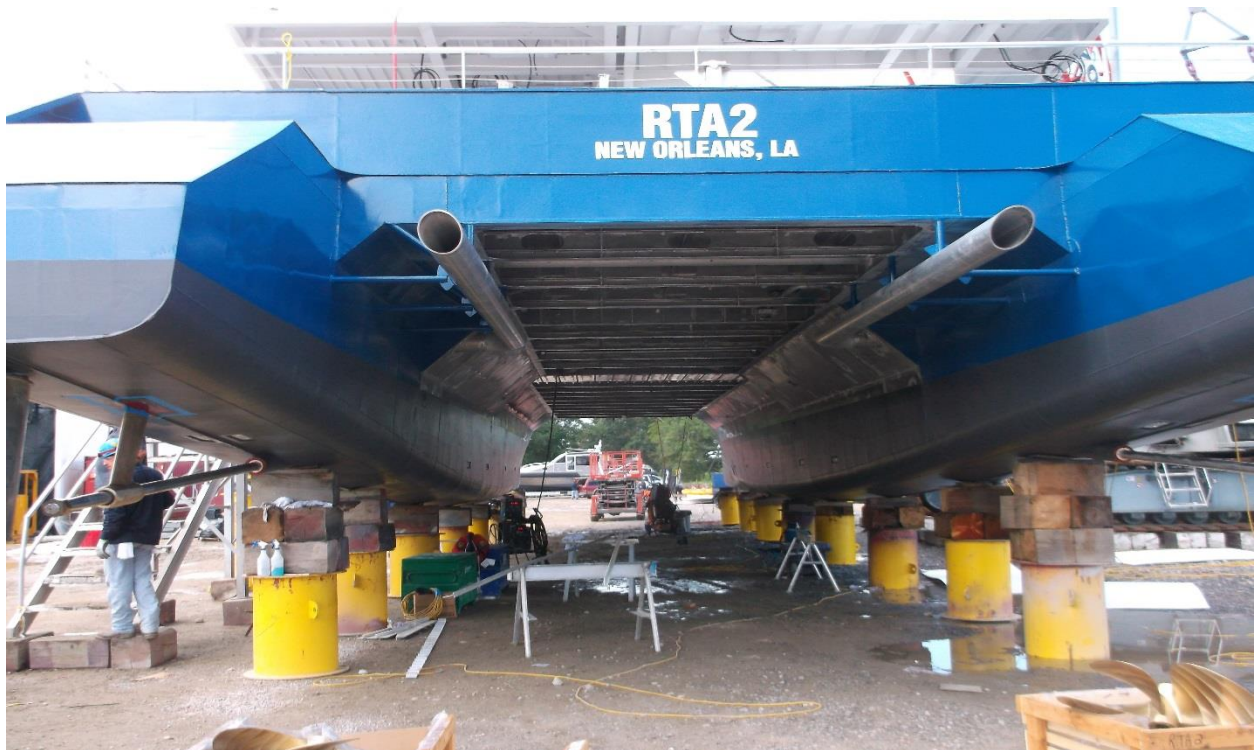
Aft view with propellers preparing to install onto propulsion shafts

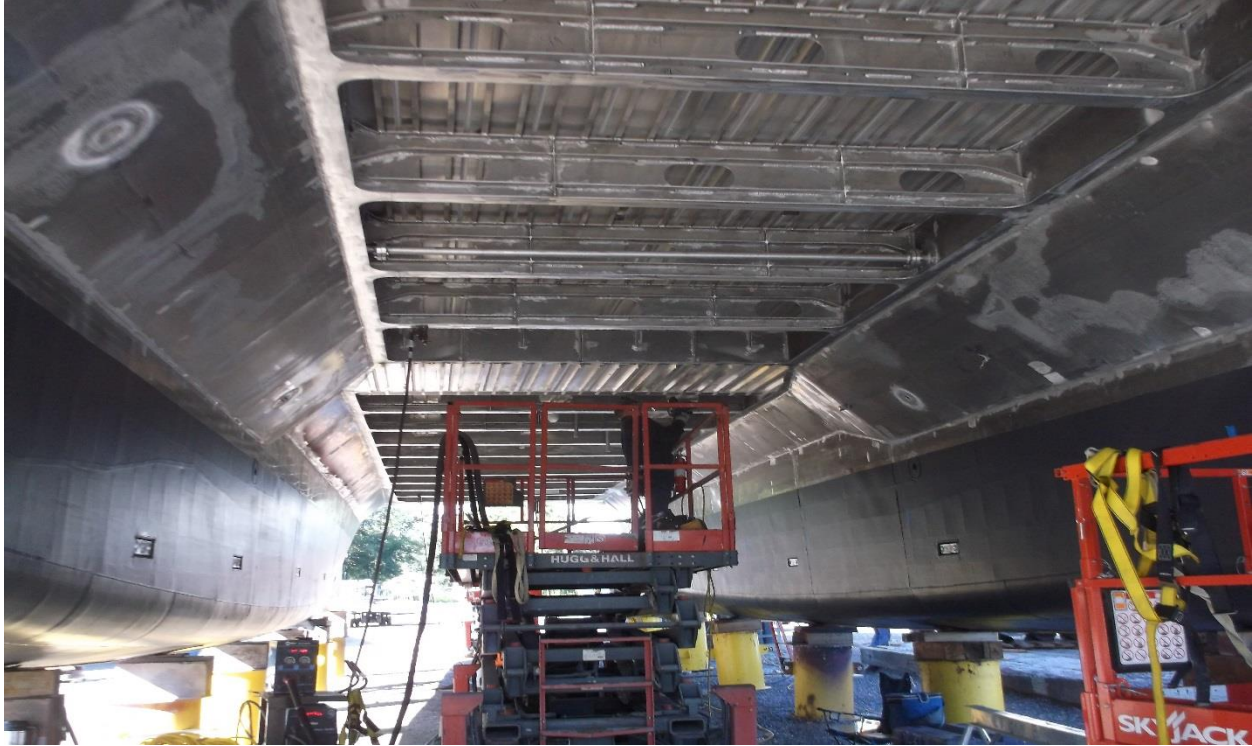
View of worker installing first section of aluminum sheathing to under bridge structure

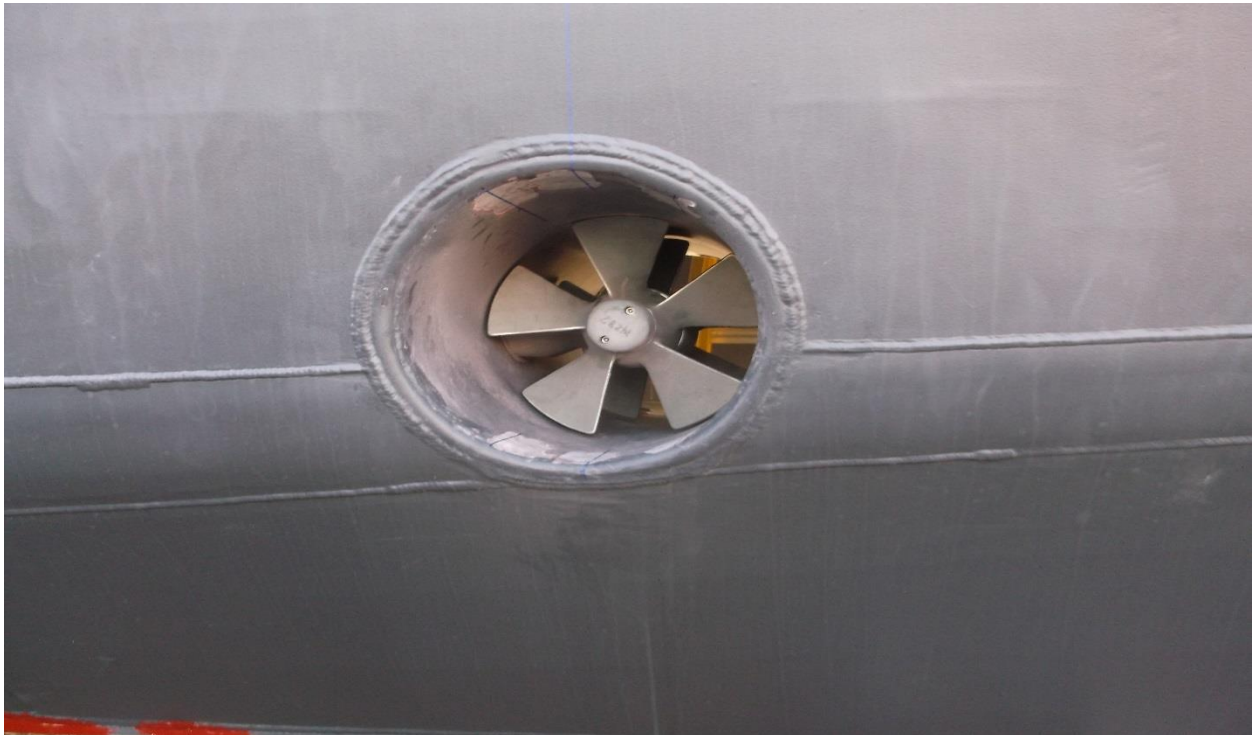
Starboard bow thruster gear drive unit with propellers installed

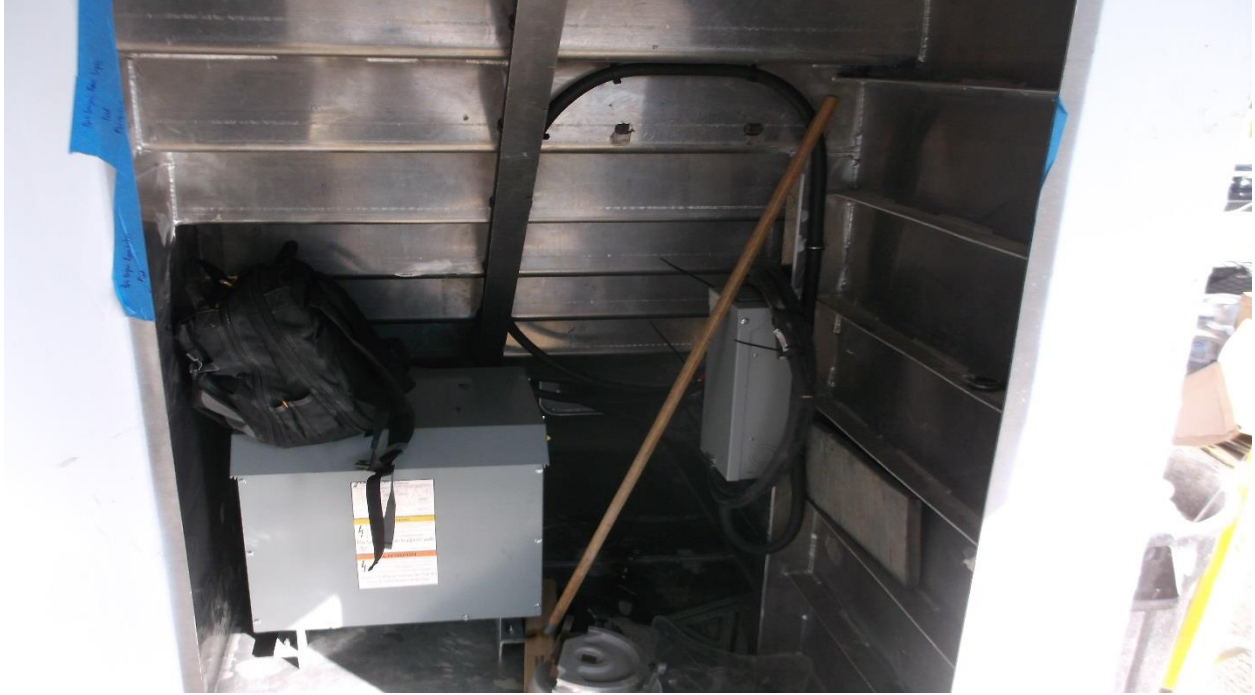
Aft stairs storage room having transformer, control panel and cabling for shore power installed

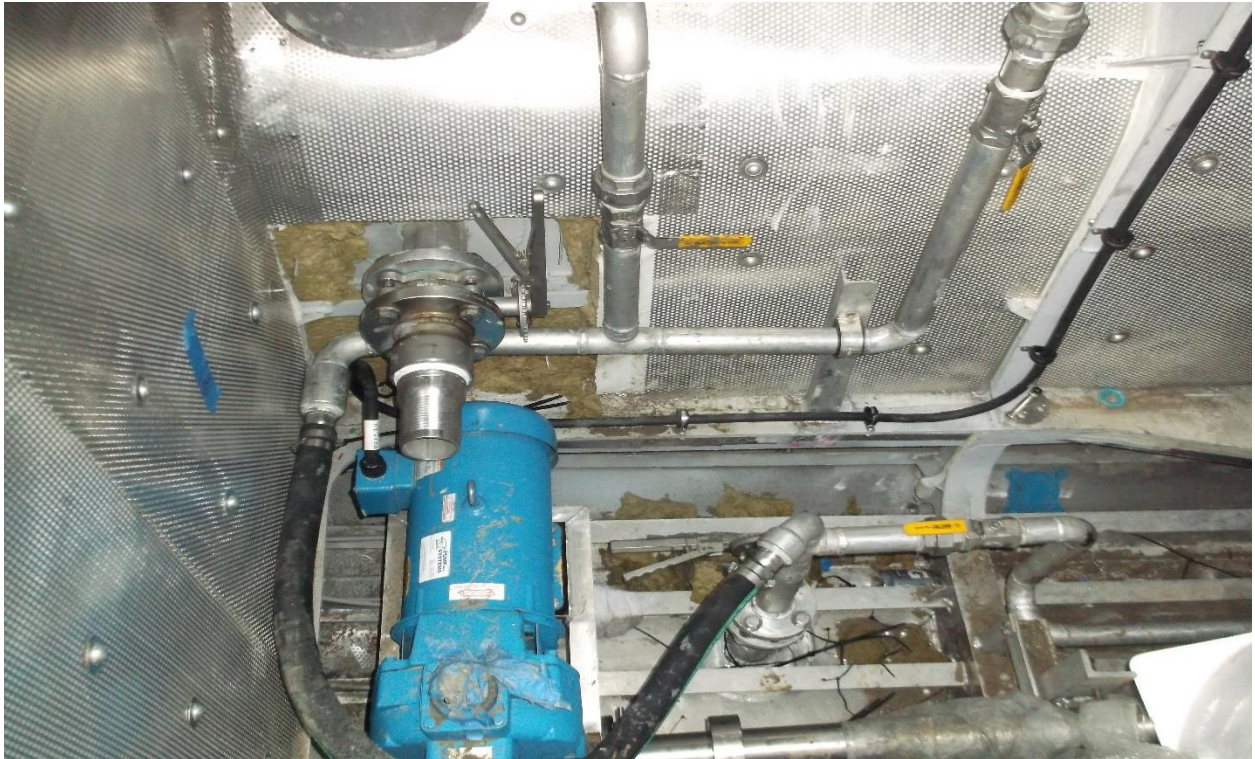
Bilge pump and associated piping installed inside the aft starboard machinery compartment

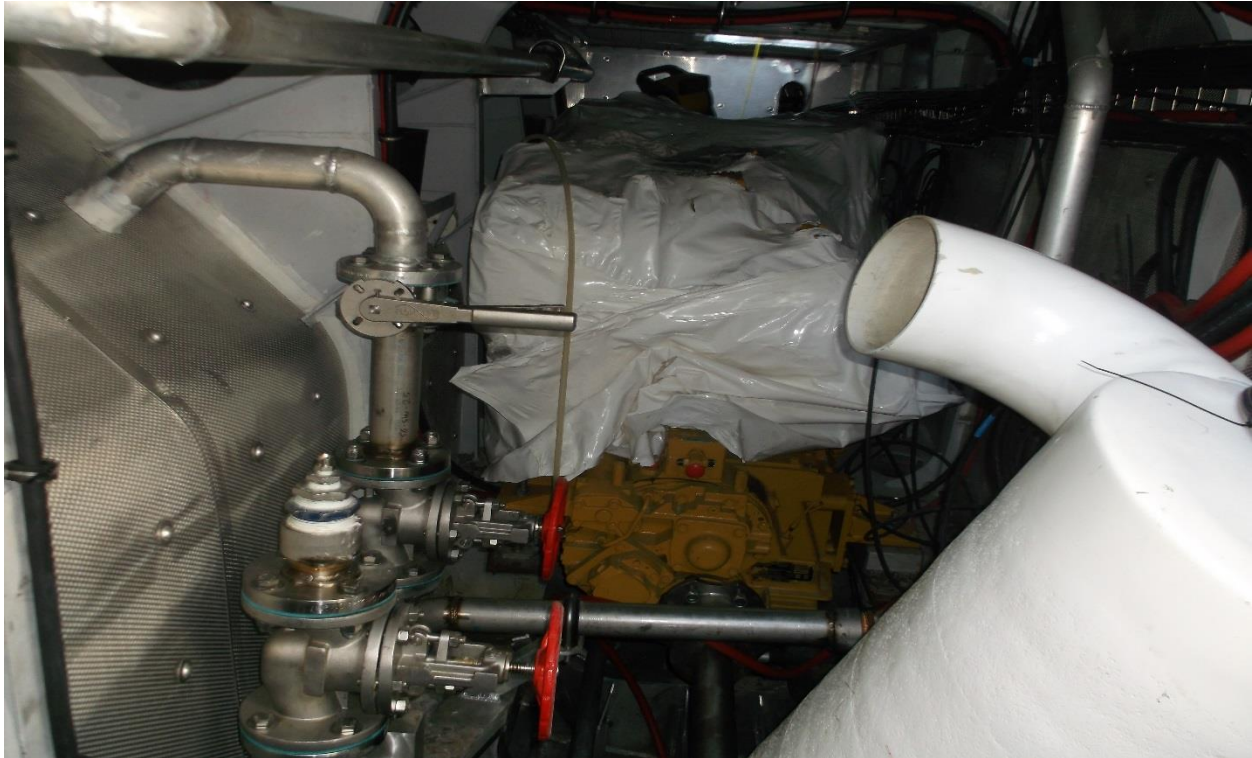
Aft view of starboard machinery compartment with cooling water piping and valves

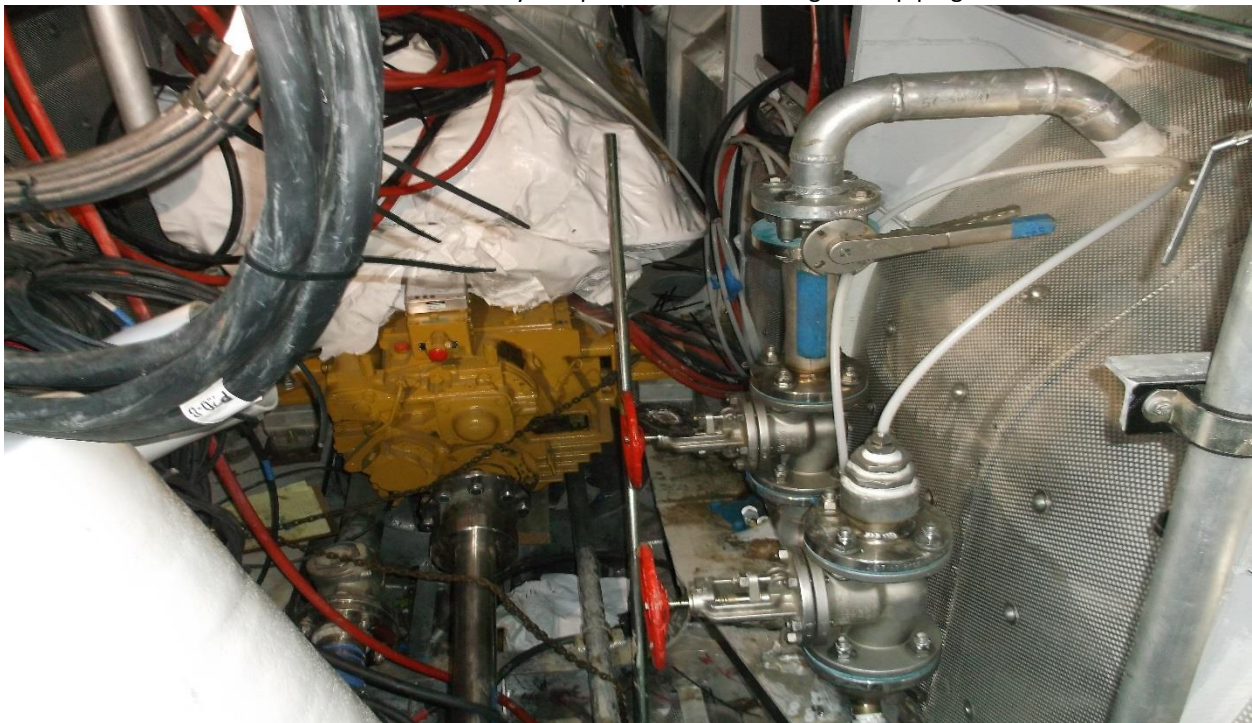
Port machinery compartment having cooling water piping and valves installed

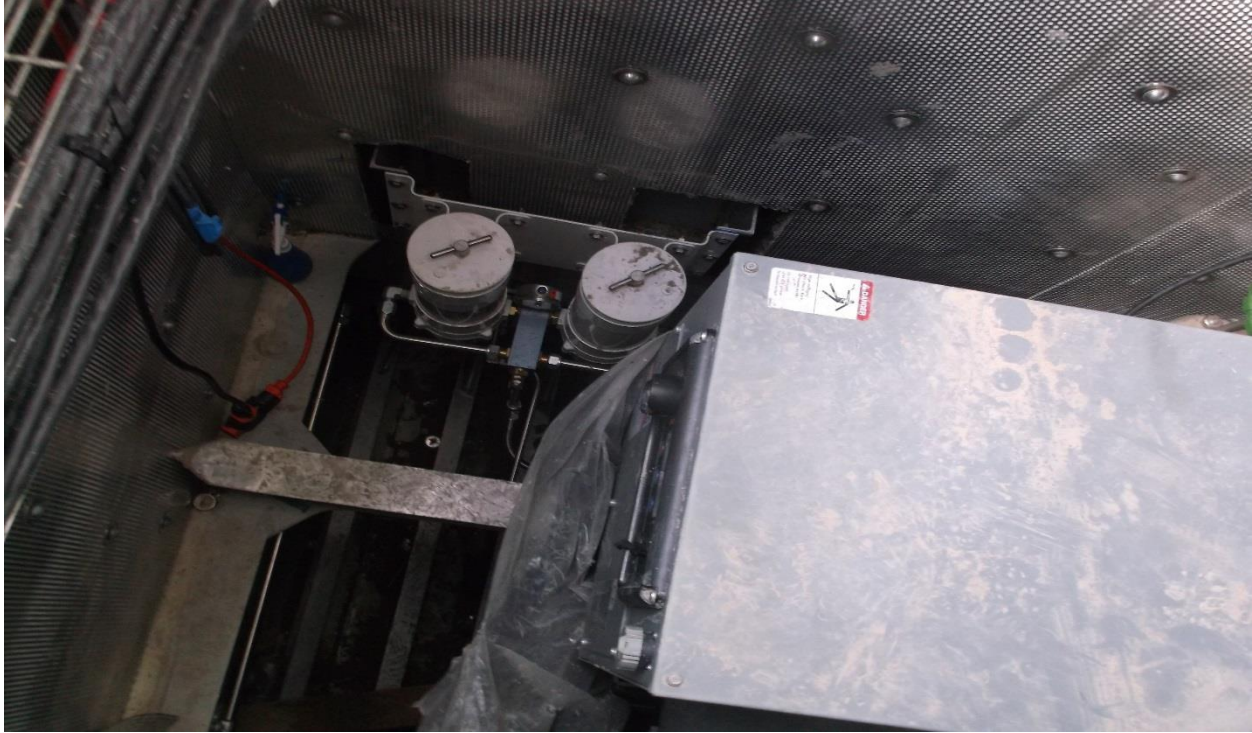
Port machinery compartment having fuel oil filters for generators installed onto forward bulkhead

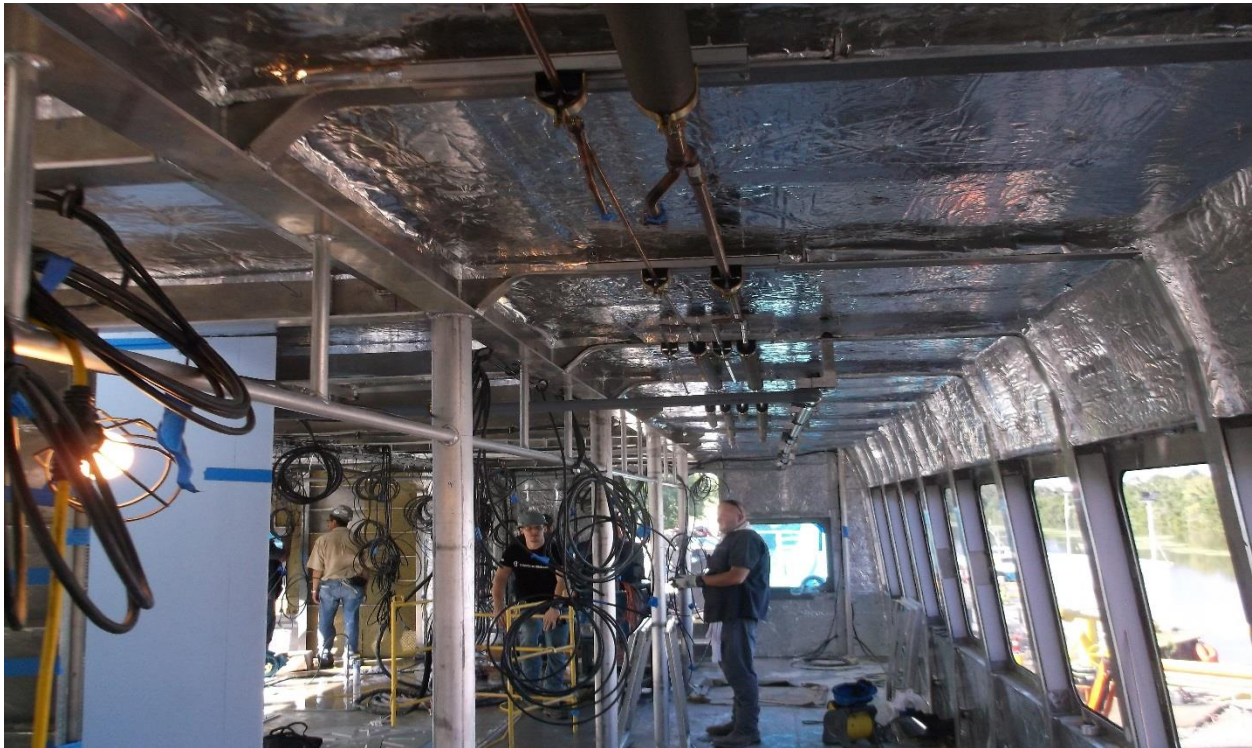
Refrigerant piping and insulation installing into ceiling of starboard side deckhouse

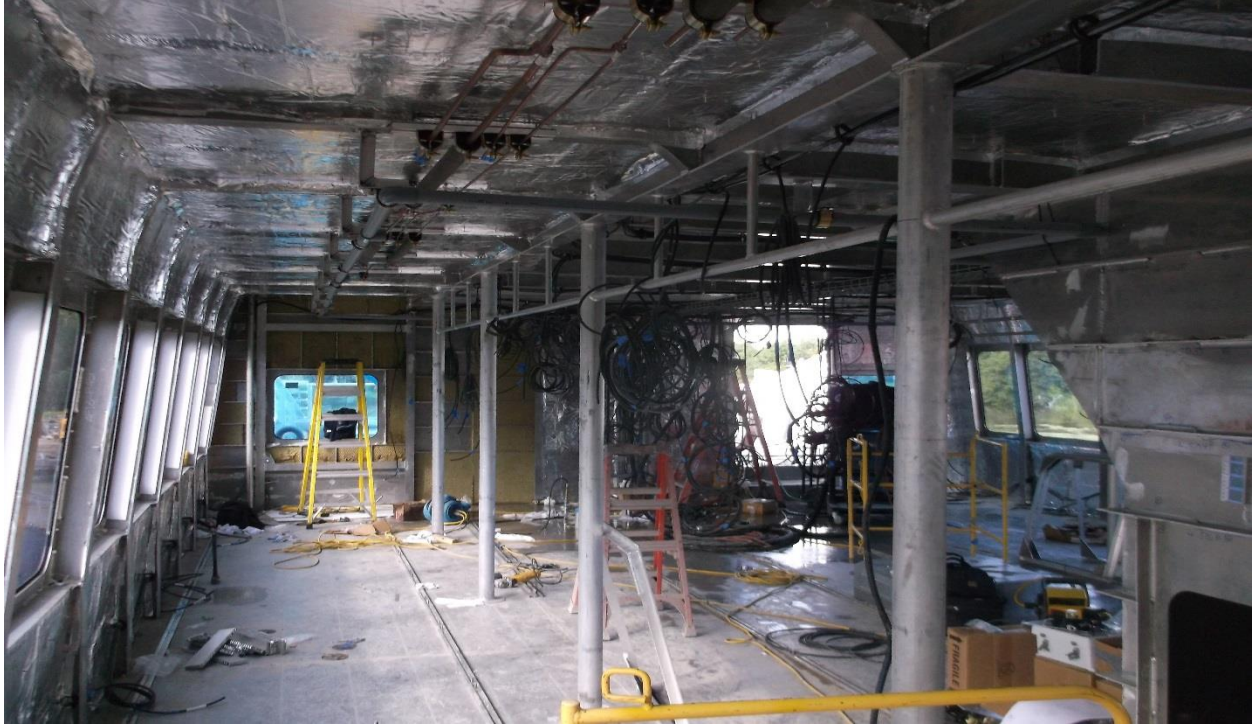
Portside ceiling view of refrigerant and condensation piping installing

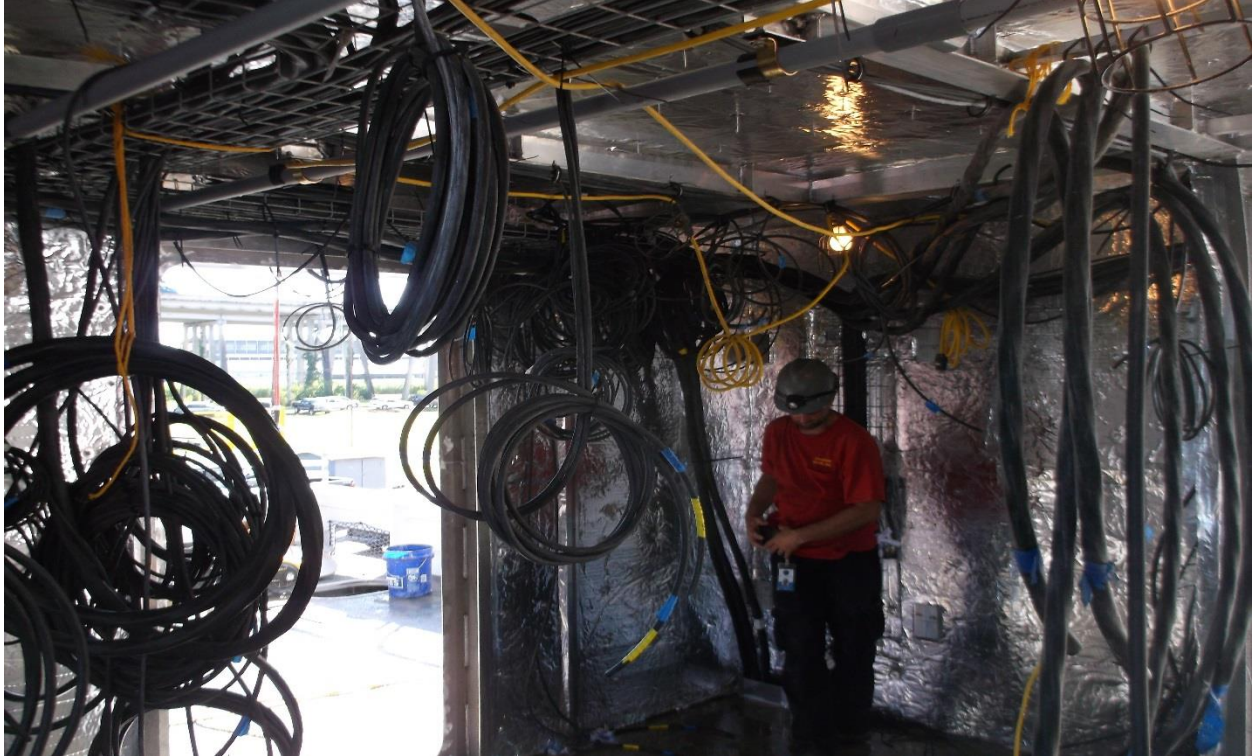
Aft port and starboard views inside deckhouse having cabling pulled to and from machinery spaces and elsewhere

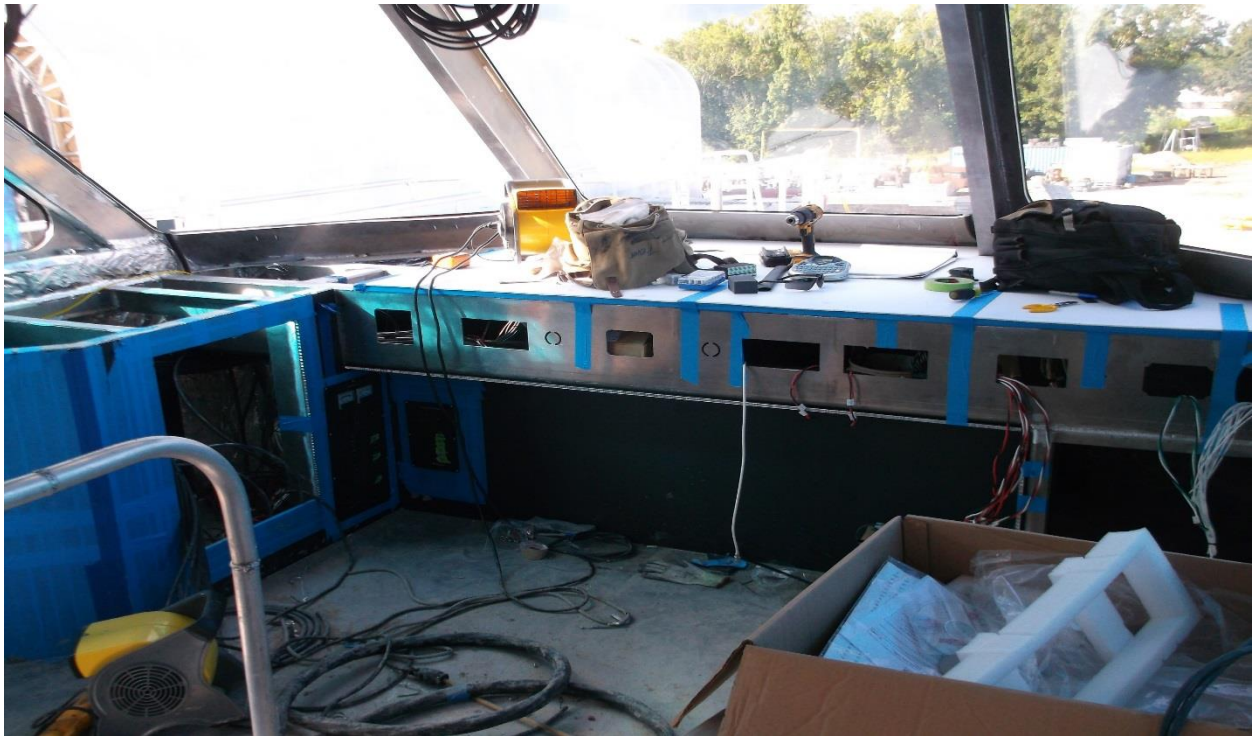
Pilothouse view and internal view of console with electrical cabling and components installing

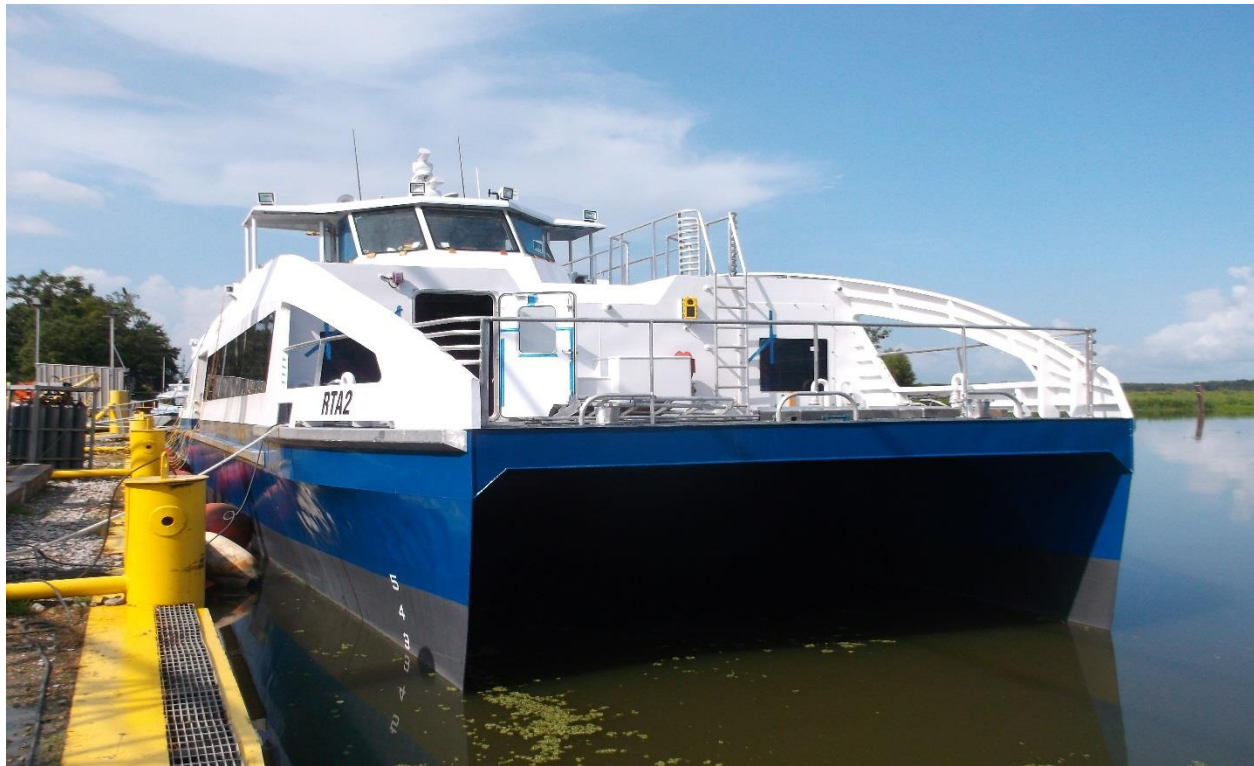
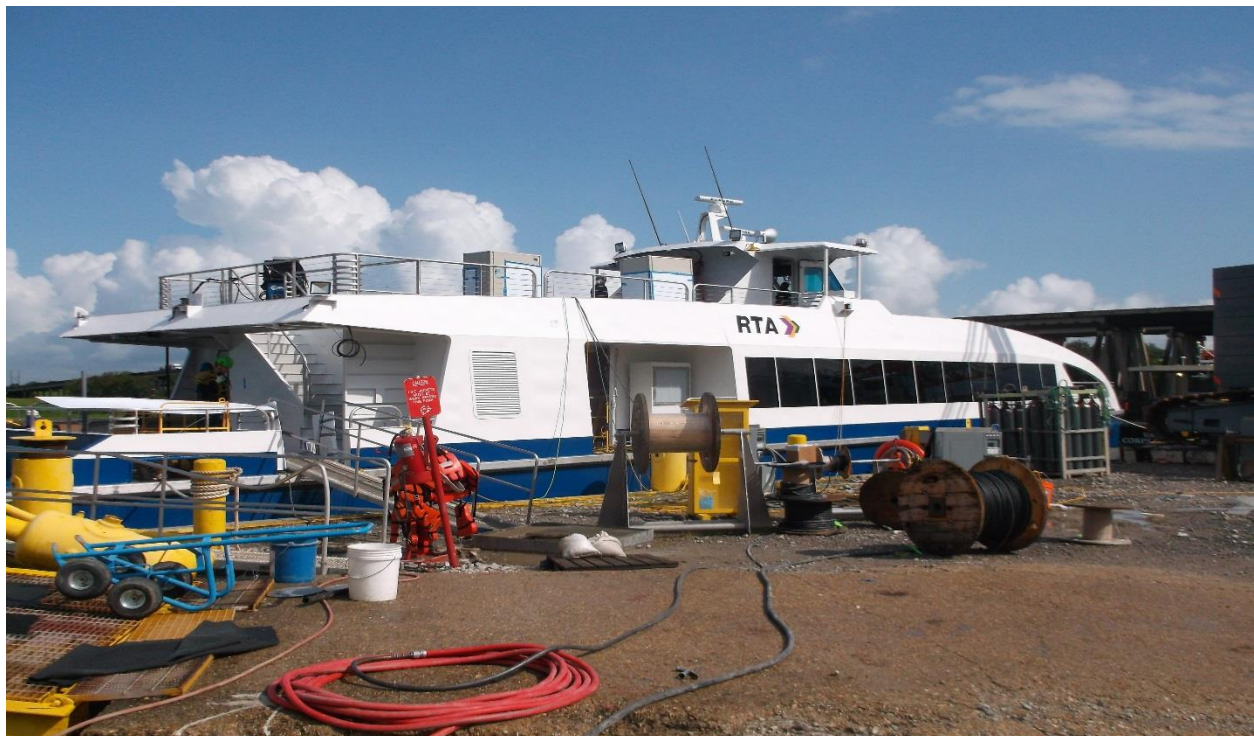
Views of vessel dockside

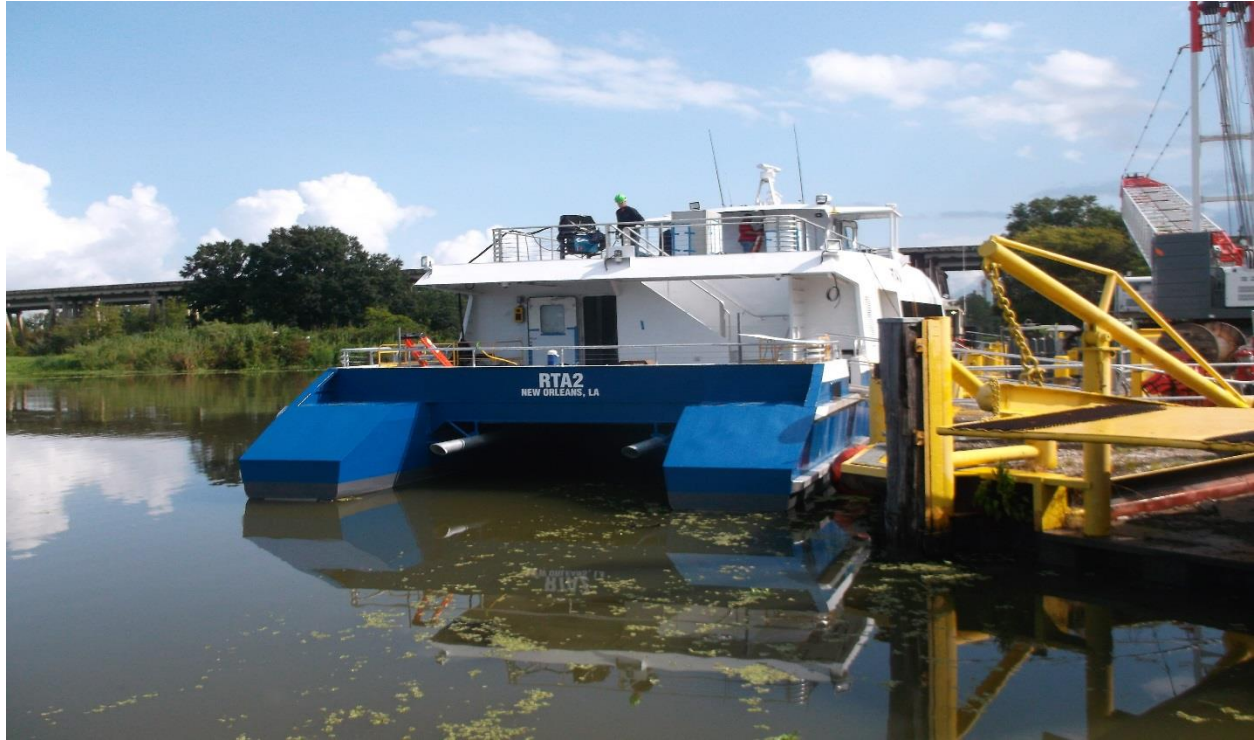
Stern end

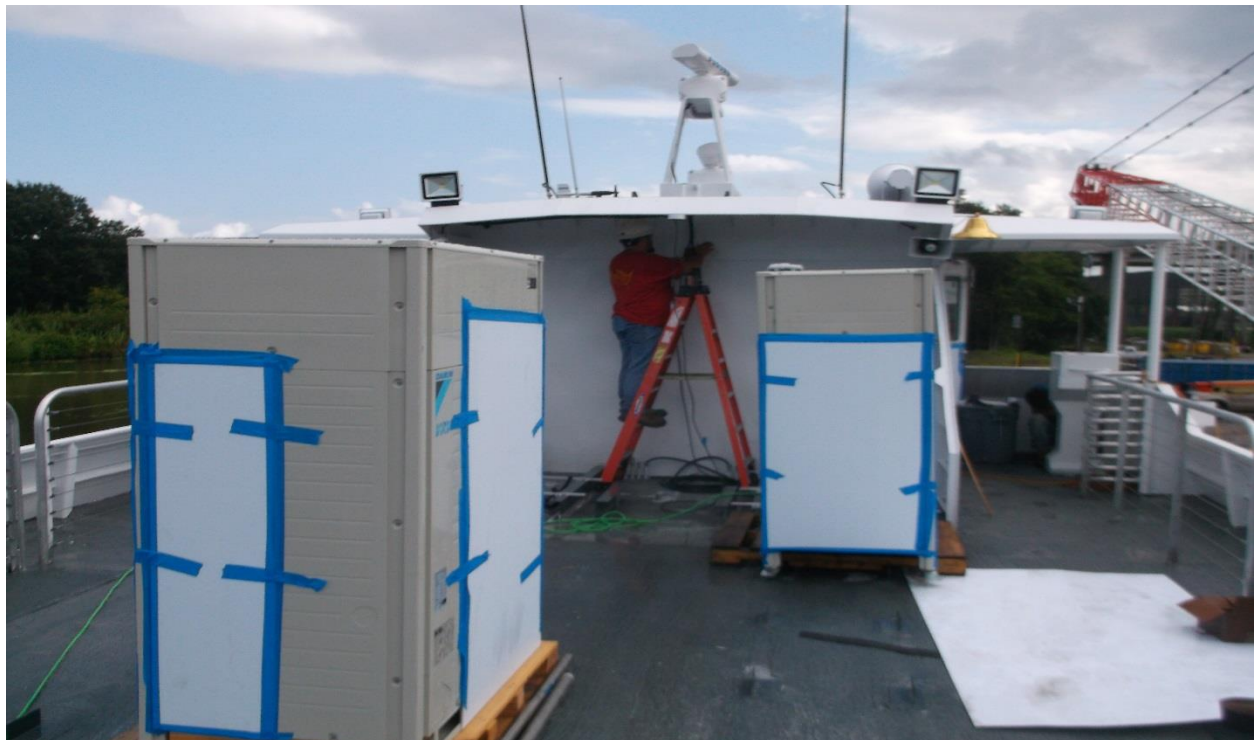
View of upper deck having HVAC condenser units onboard and electrician installing cables

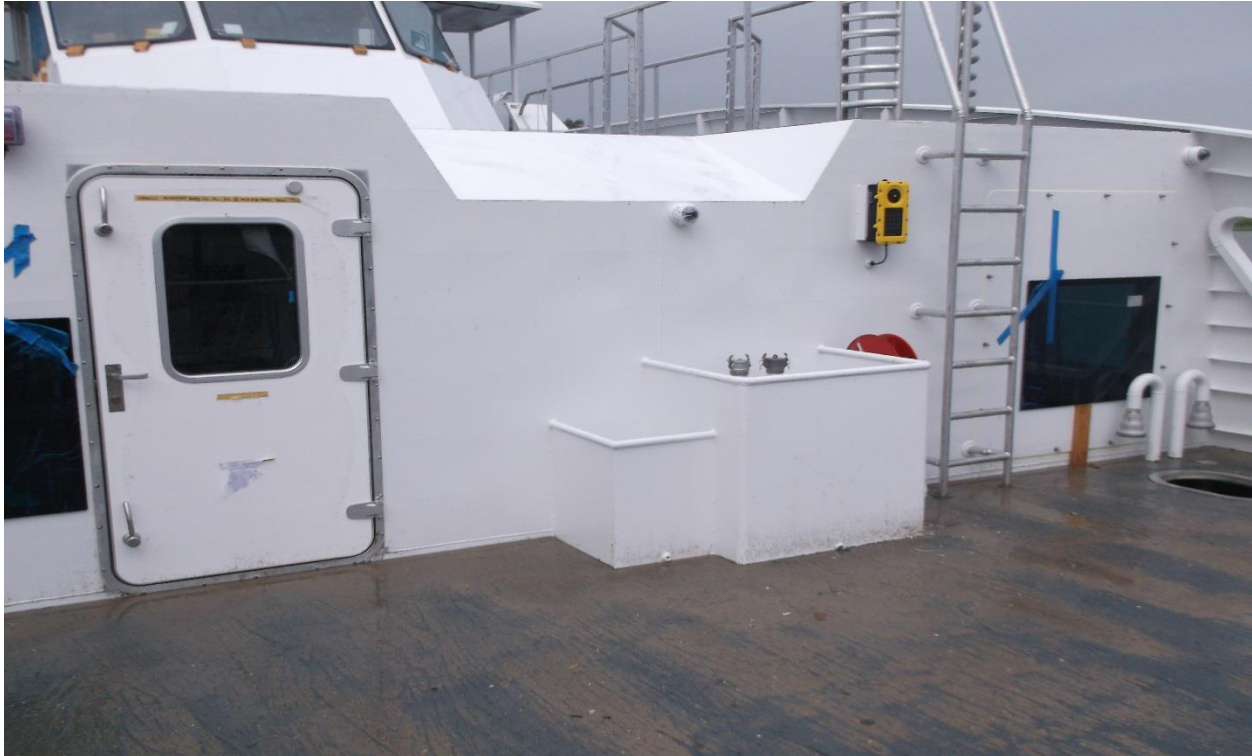
Bow main deck area having exterior door, hailing station and camera installed

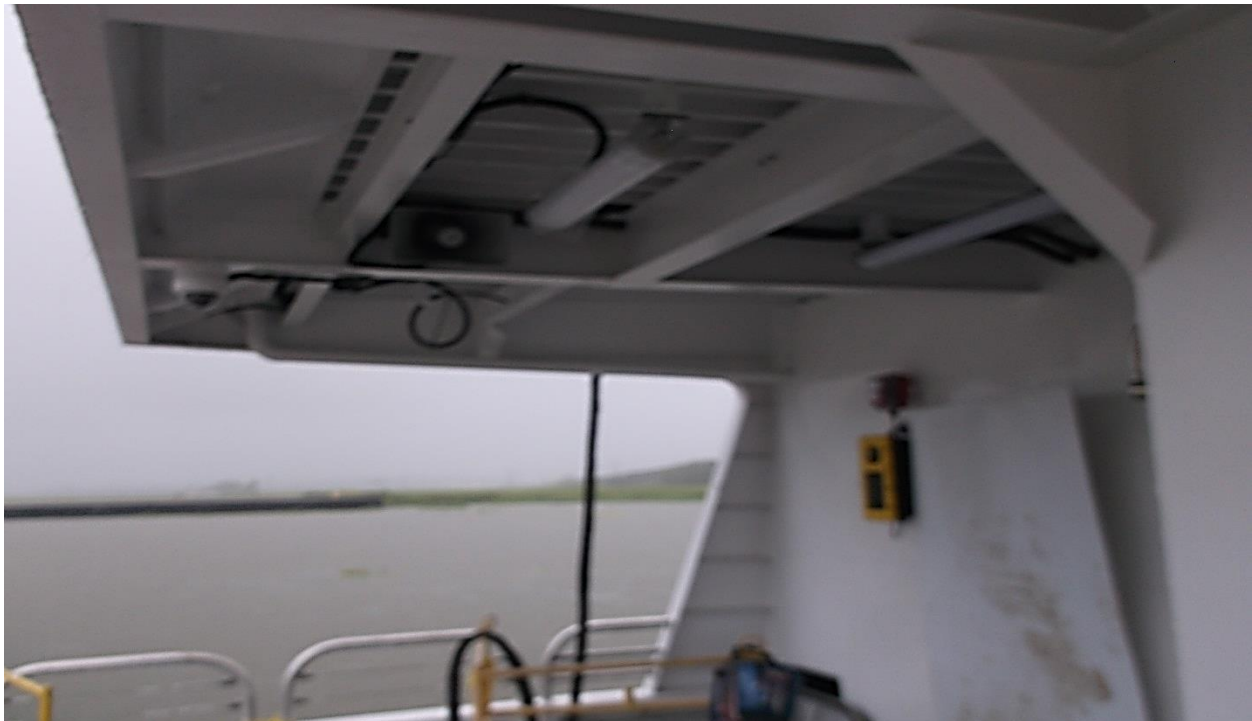
Aft main deck having lighting, cameras and hailing station installed

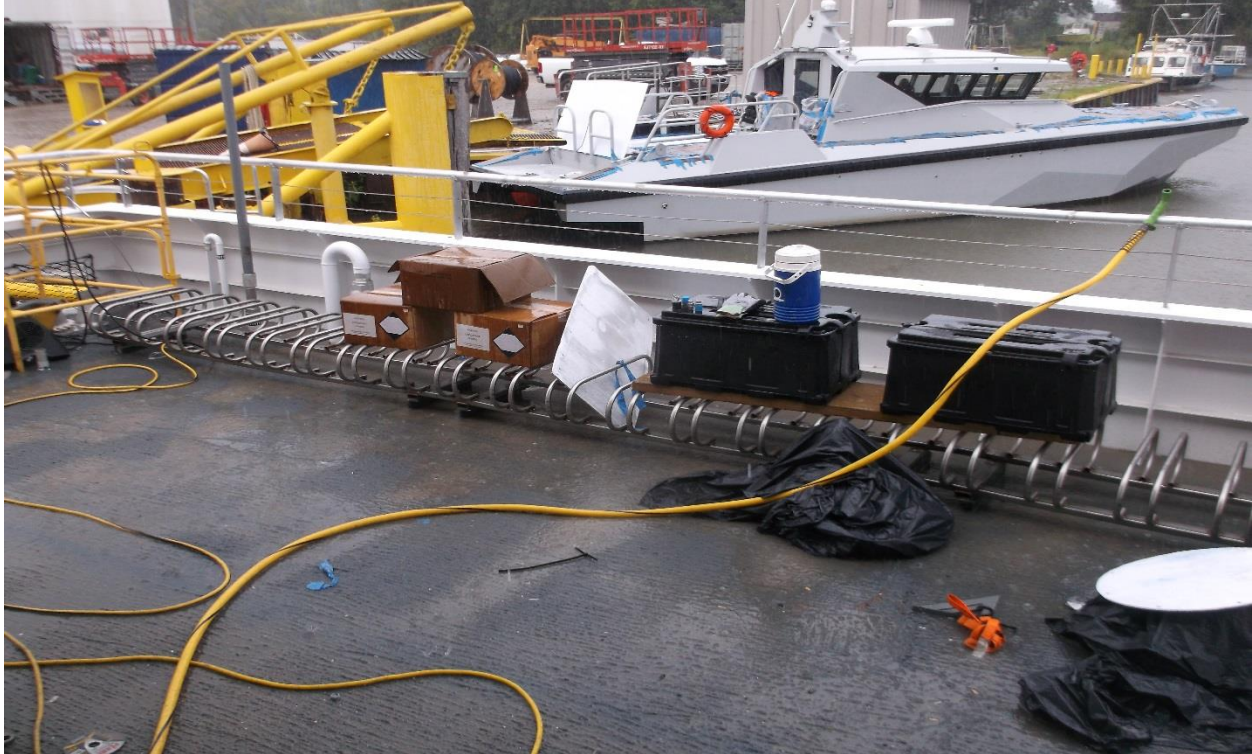
Another view of aft main deck having bike/scooter wheel rack installed

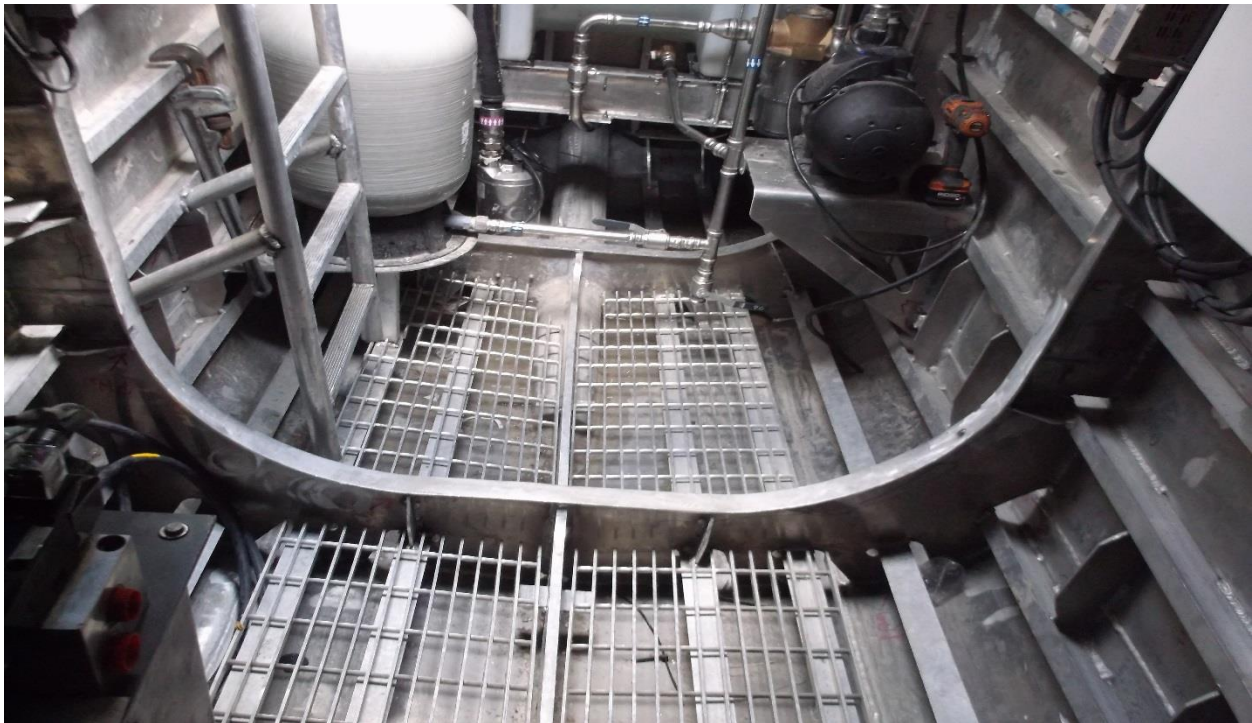
Typical view inside no.5 steering compartments having grating installed

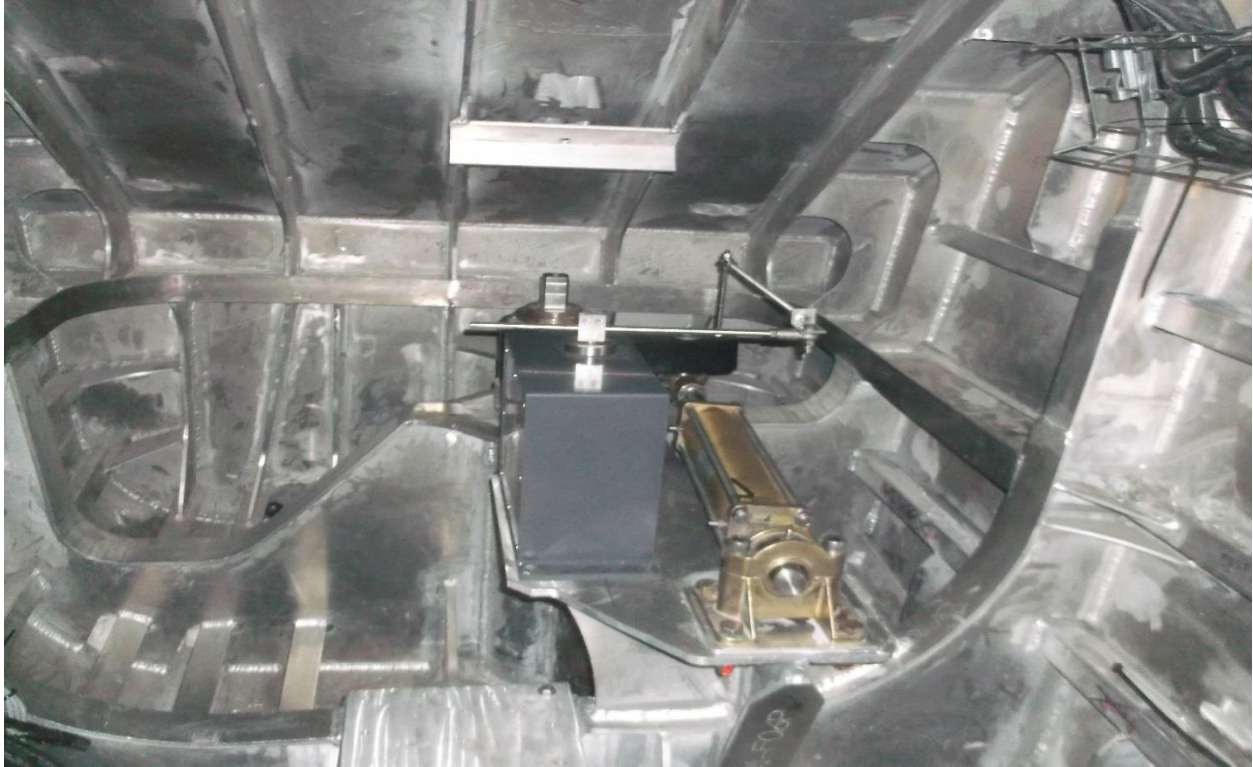
View of steering ram, tiler arm and limit switch installed on the starboard side

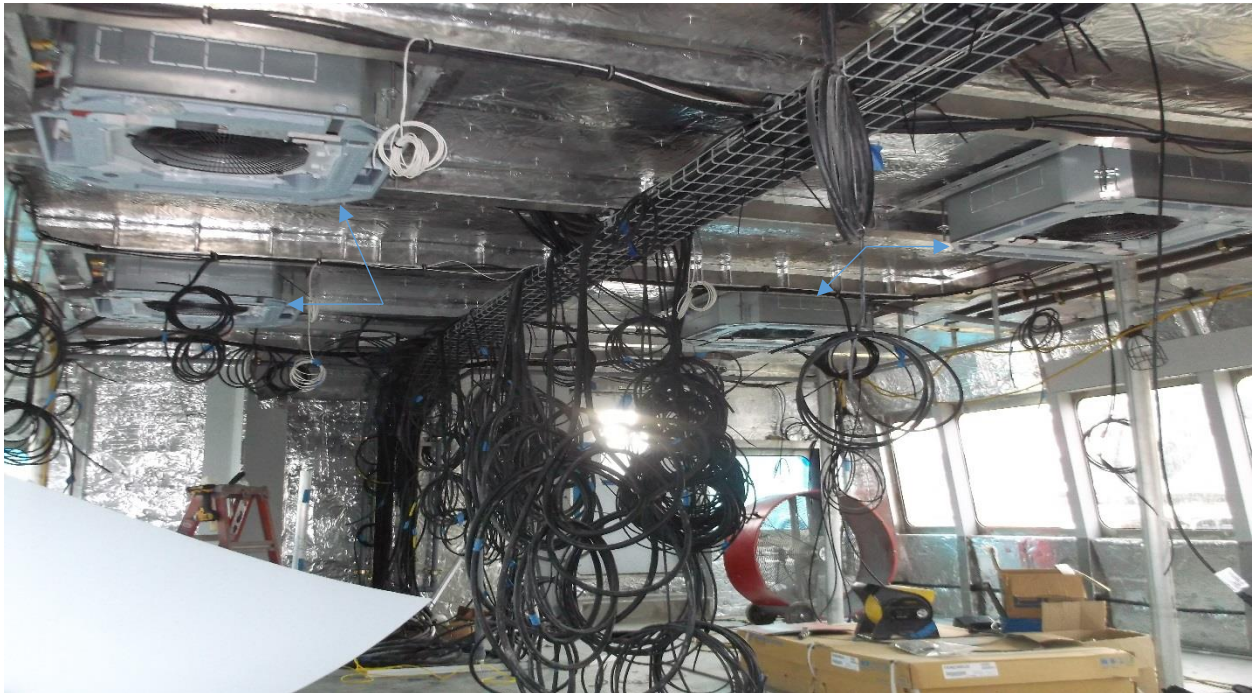
Deckhouse forward view having HVAC evaporator units installed in ceiling

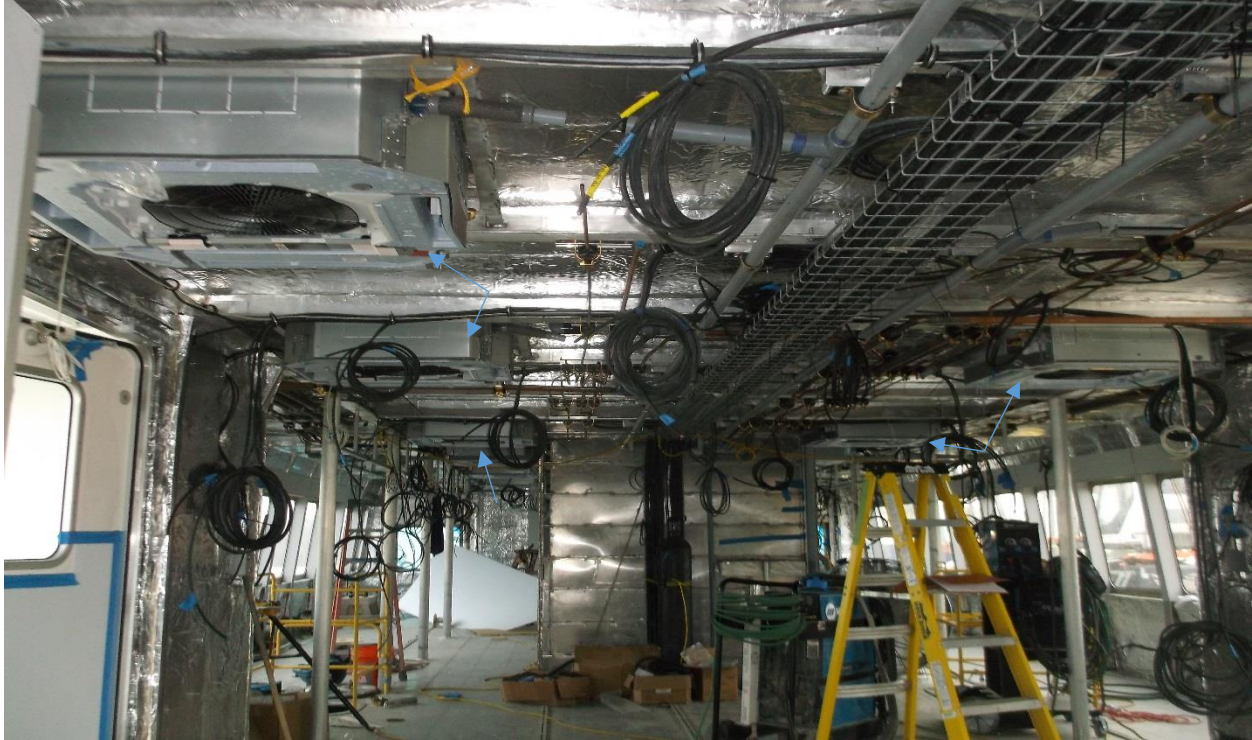
Another view of aft deckhouse ceiling with HVAC evaporator units installed

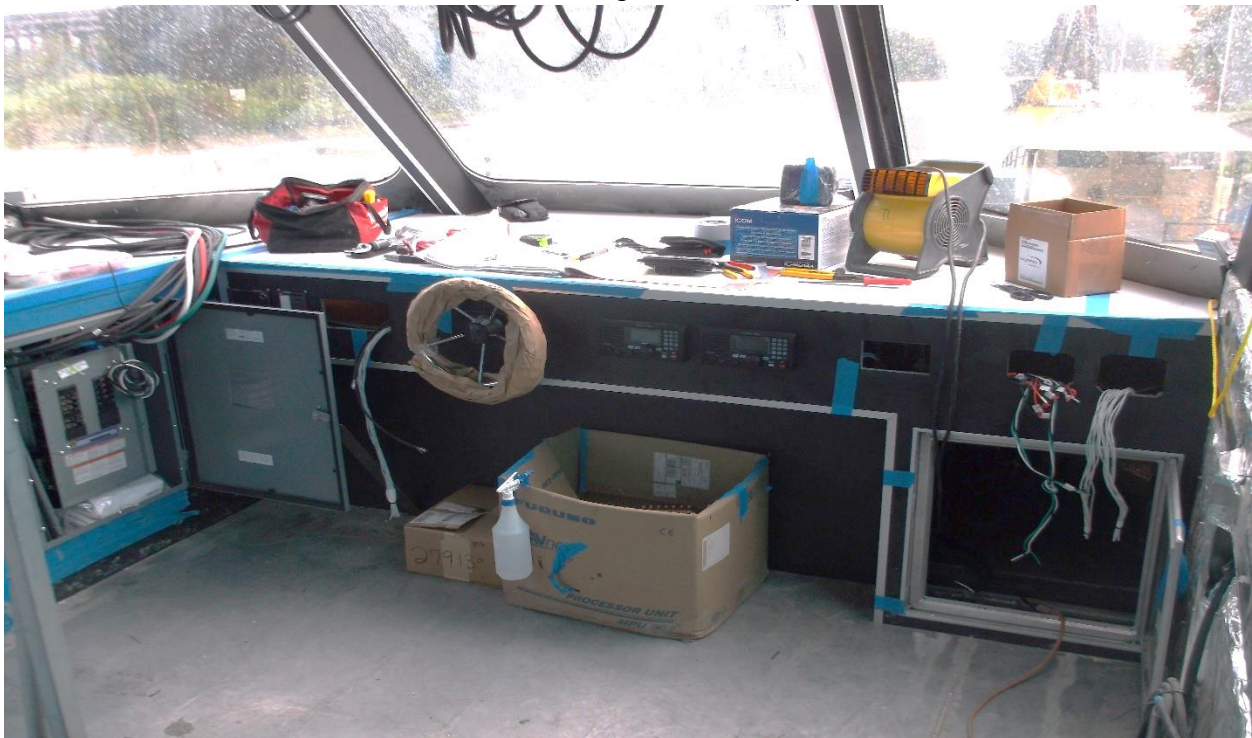
View of pilothouse console having VHF radios installed and main electrical circuit panel being wired
